**The Kogarah War Memorial Olympic Swimming Pool Centre  
At  
Carss Park**

**Report**

**Pools and Tanks Structures and Finishes  
and  
Filtration and Water Treatment Plant**

**19 April 2011**

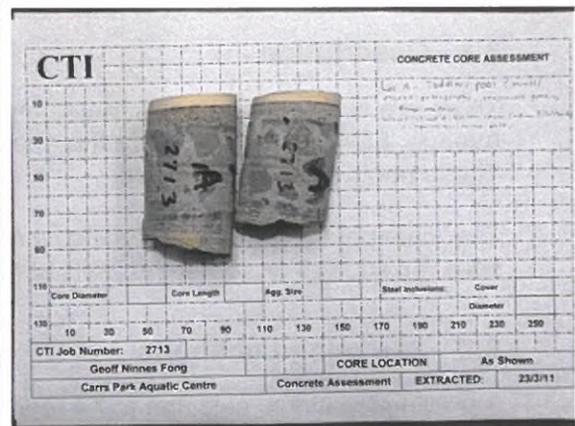
Cores from sampling Location A (including tile and mortar layer)

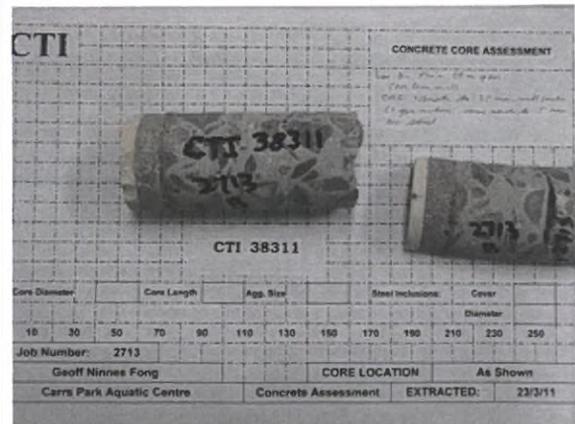
Cores from Location B (including tile and mortar layer)

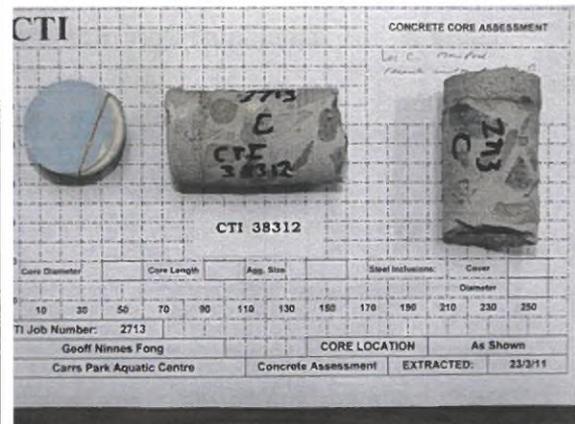
Cores from Location C (tiles removed but some mortar remaining)

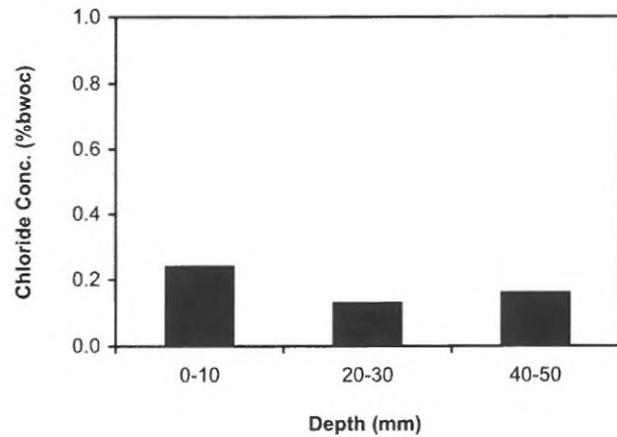
**Location A – Toddlers Pool, N wall**

Depth (mm)	Chloride (ppm)	Chloride (%bwoc)
0-10	360	0.24
20-30	200	0.13
40-50	240	0.16

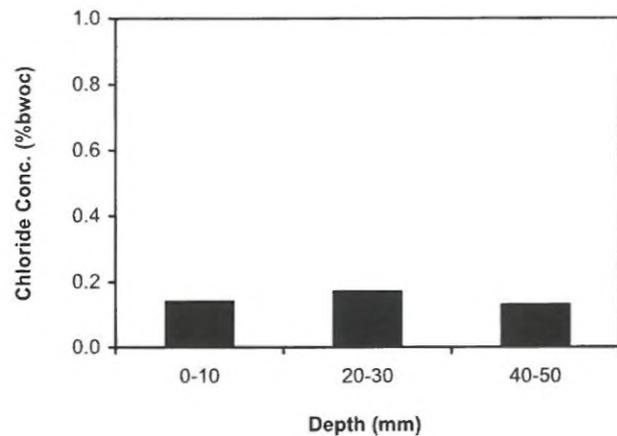
**Location B – Main Pool, N wall, E end**

Depth (mm)	Chloride (ppm)	Chloride (%bwoc)
0-10	220	0.14
20-30	260	0.17
40-50	200	0.13

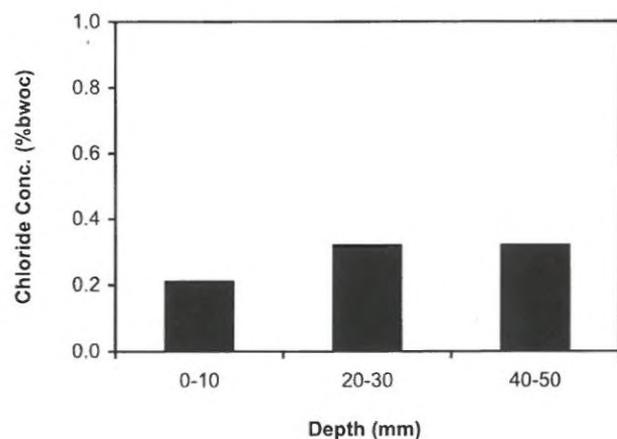
**Location C – Main Pool, N wall, W end**

Depth (mm)	Chloride (ppm)	Chloride (%bwoc)
0-10	320	0.21
20-30	480	0.32
40-50	480	0.32

Slightly elevated chlorides were experienced in the western end of the north wall of the main pool, but even these remain well below the threshold for corrosion concerns.
