# STRUCTURAL PEER REVIEW

14-16 Victoria St Kogarah

Prepared for  
Georges River Council

21 August 2019

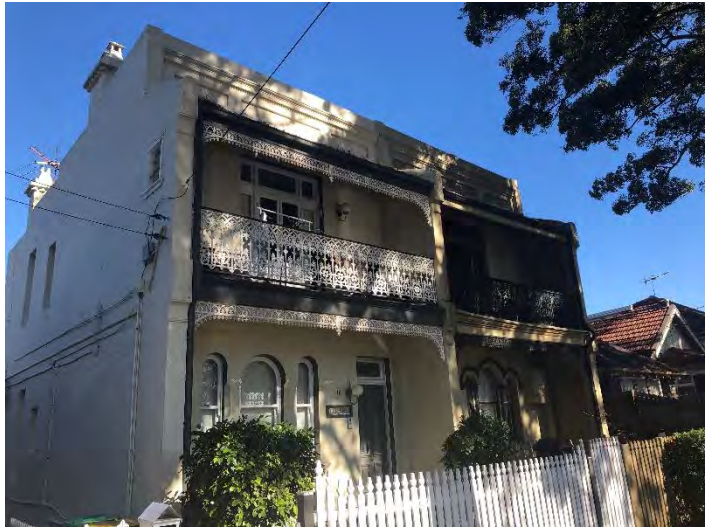
Sagging in U14 balcony

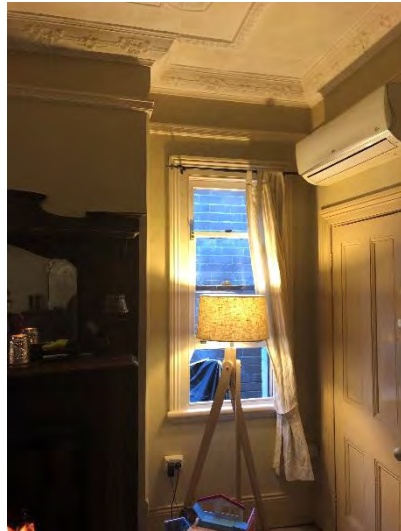
14 Victoria Street- Internal  
Room

Minor crack on top of window

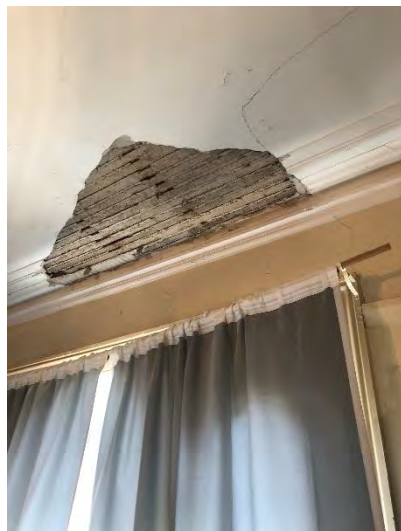
14 Victoria Street- Internal  
Room Ceiling

Cracks in Ceiling

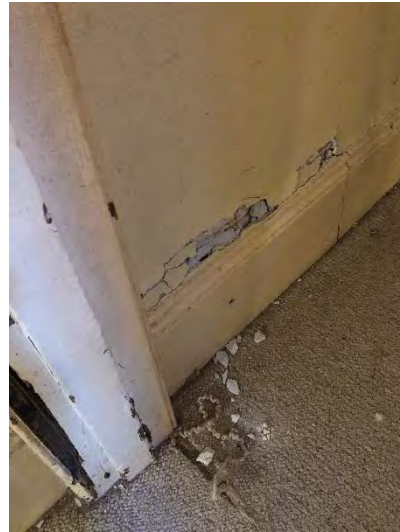
Crack on the load bearing wall

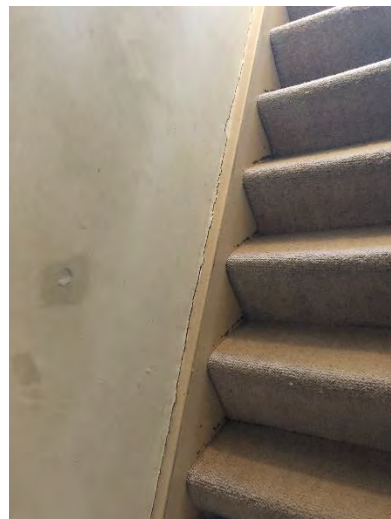
14 Victoria Street- Stair

Crack on wall next to stair stringer

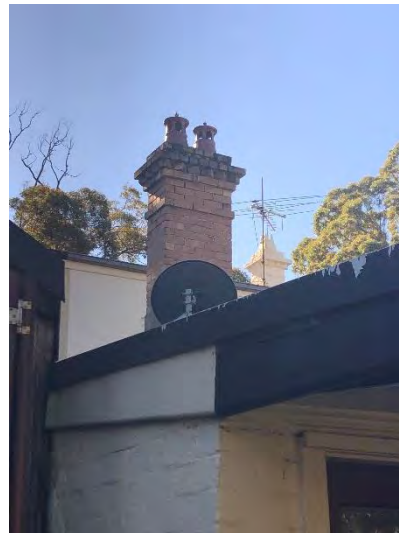
14-16 Victoria Street-  
Chimney

Structurally Loose Chimney

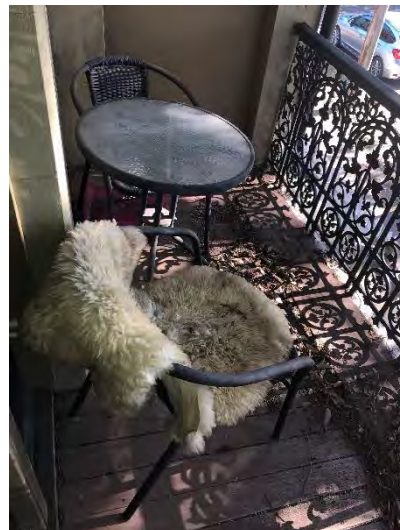
14 Victoria Street- Front  
Balcony

Structurally inadequate

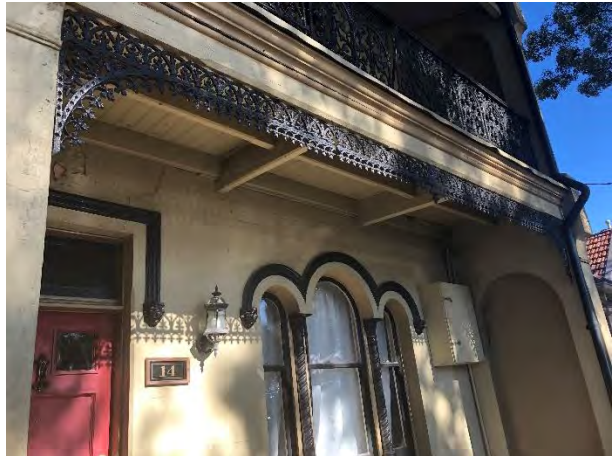
Balcony Sagging

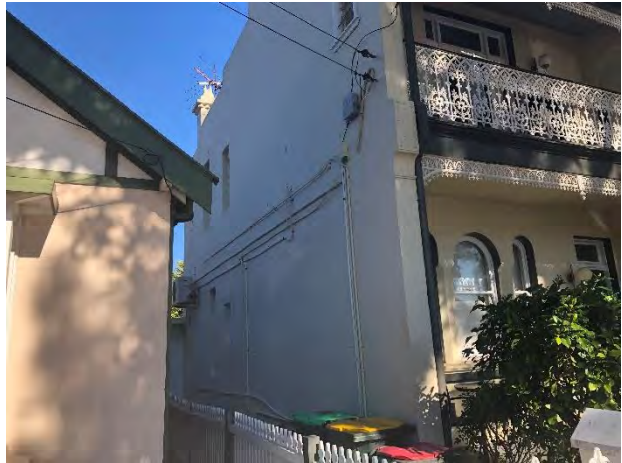
16 Victoria Street- Side  
Perimeter Brick Wall

Minor cracks

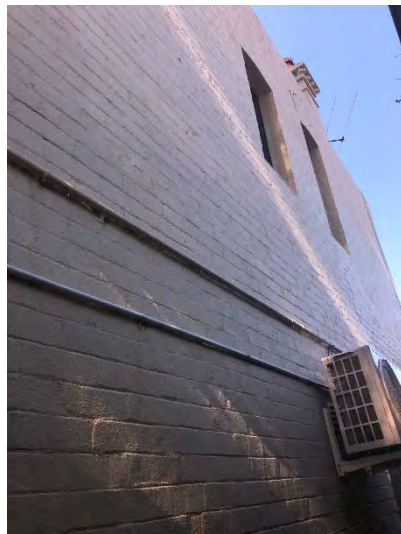
14 Victoria Street- Side  
Perimeter Brick Wall

Minor cracks

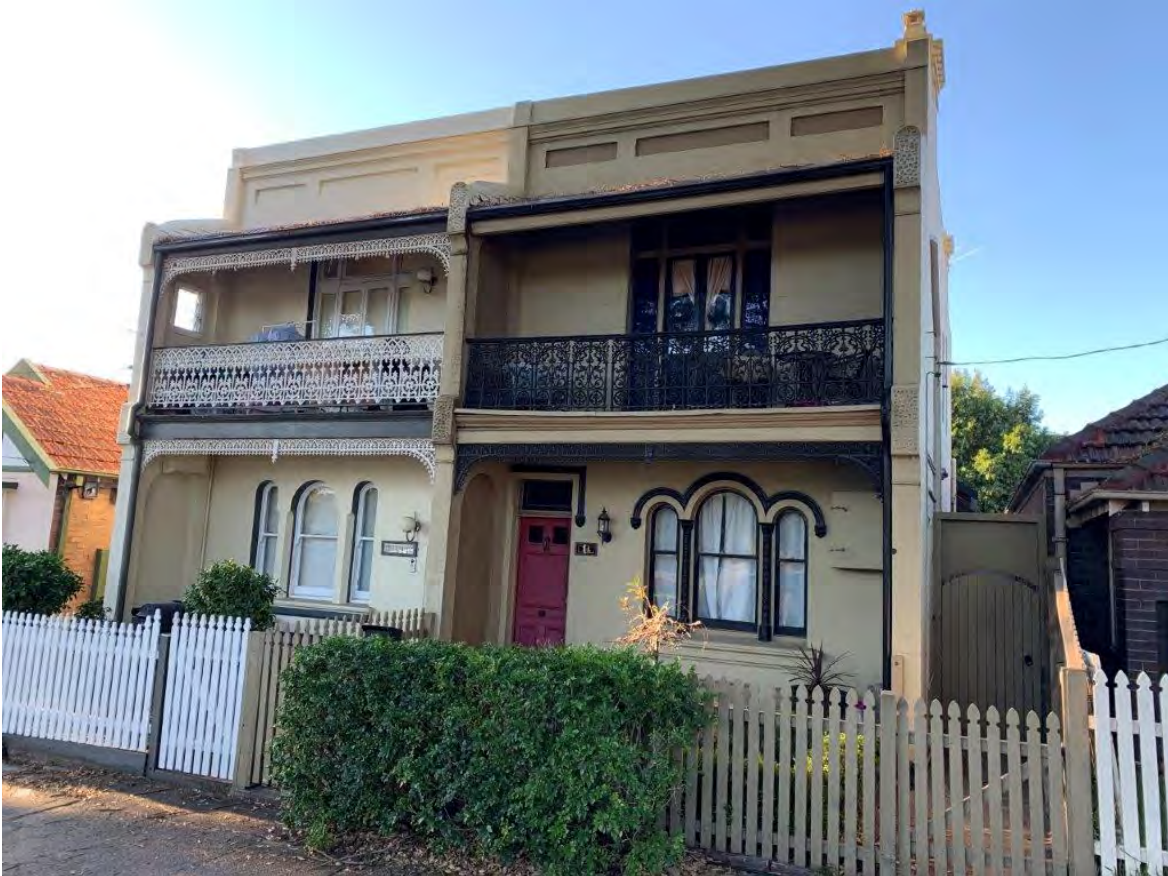
Photo 1 - Overall Photo of 14-16 Victoria Street (Sagging Balcony)

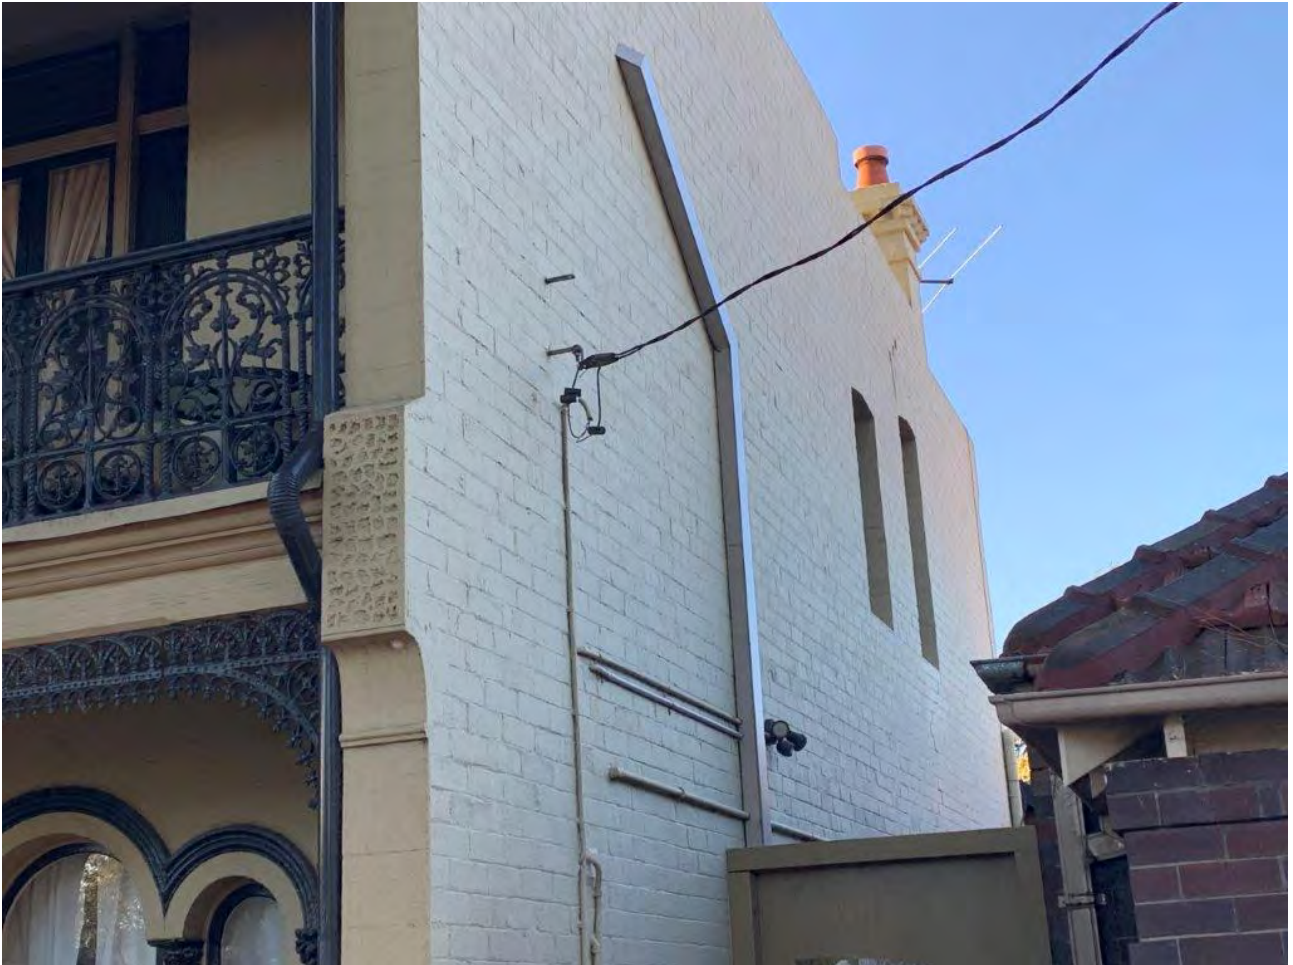
**Photo 2 - Cracks in External Brick Wall at Terrace Number 14**

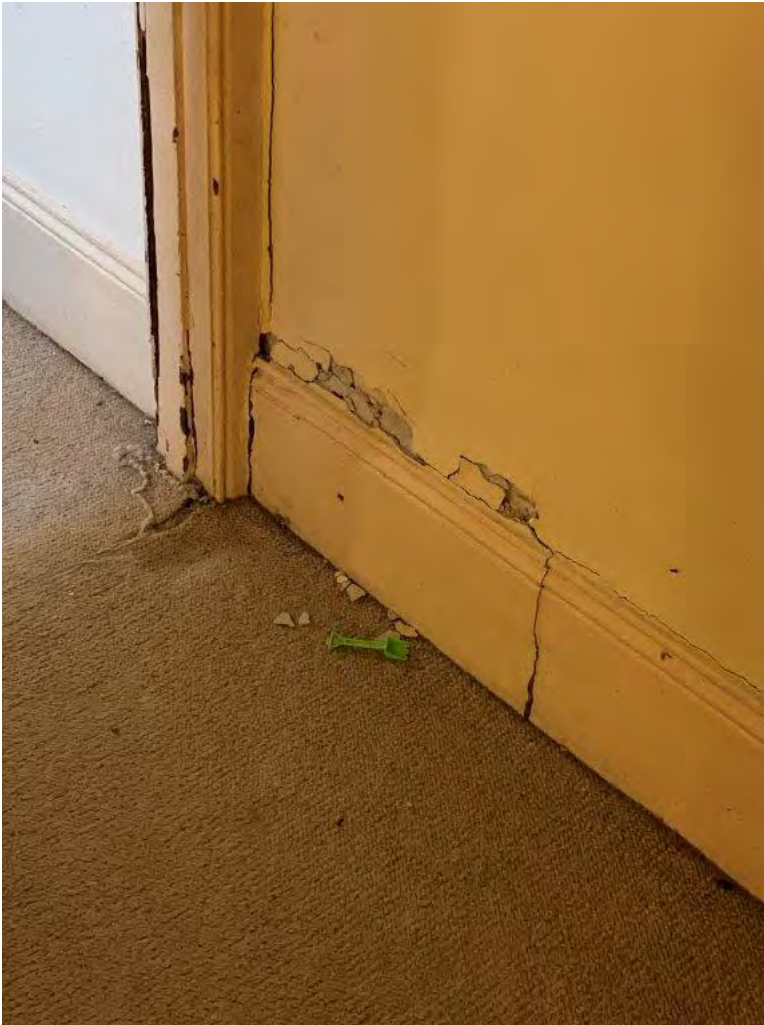
**Photo 3 - Cracks in Brick Wall**

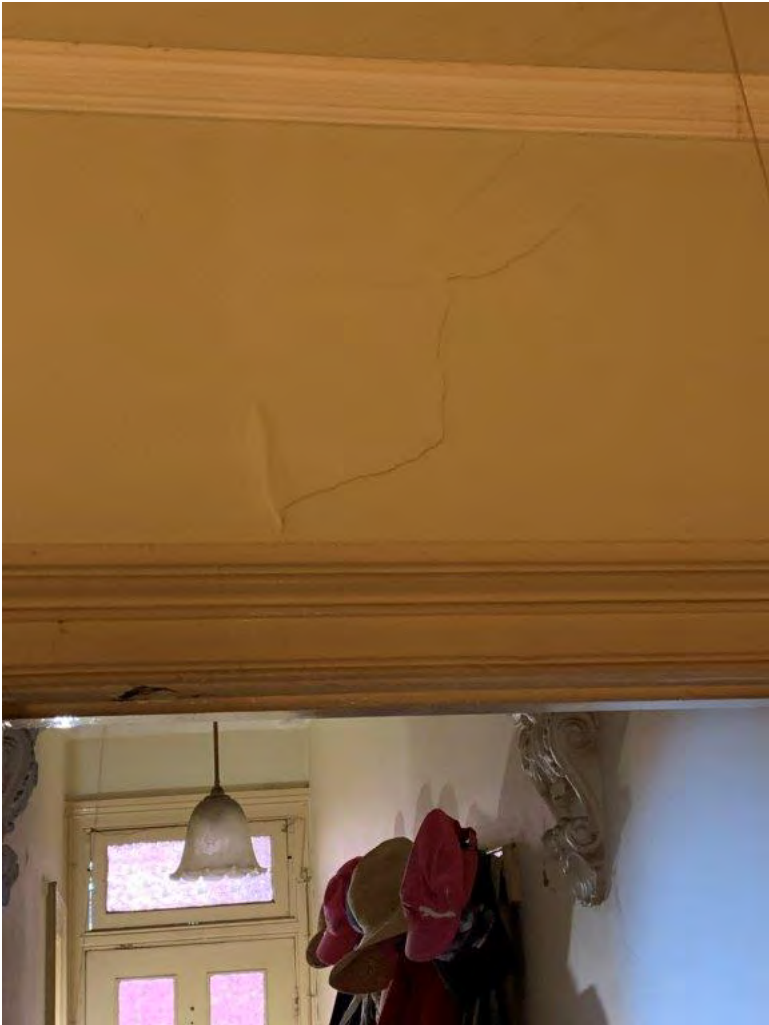
Photo 4 - Cracks in Brick Wall

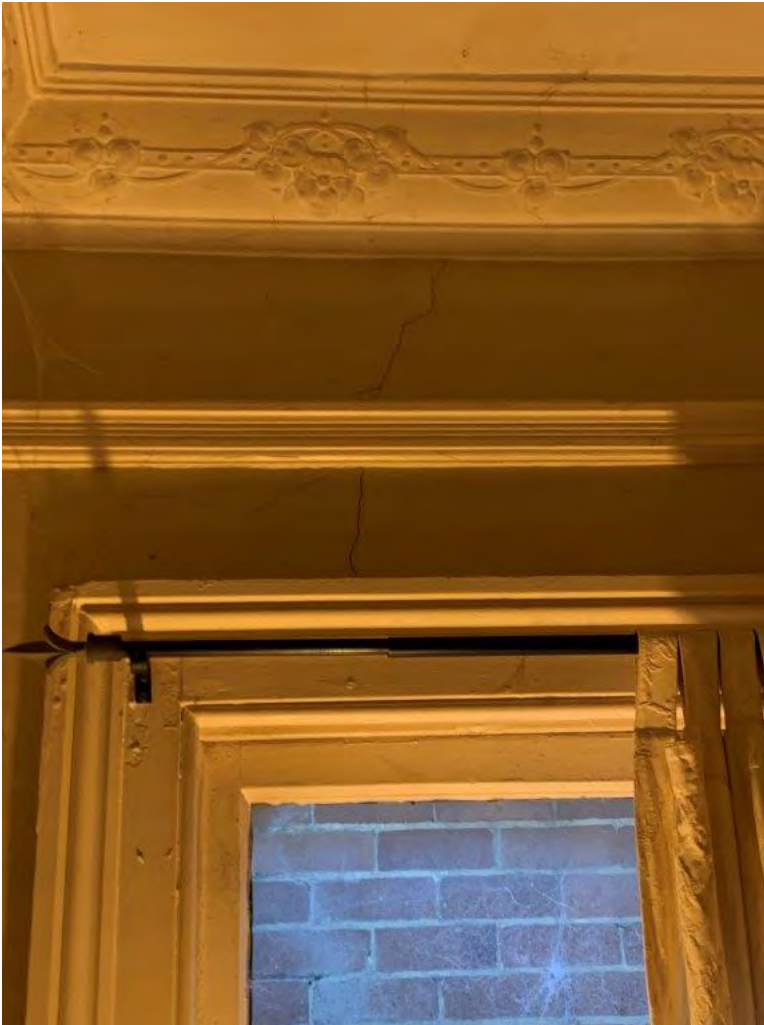
**Photo 5 Cracks in Brick Wall**

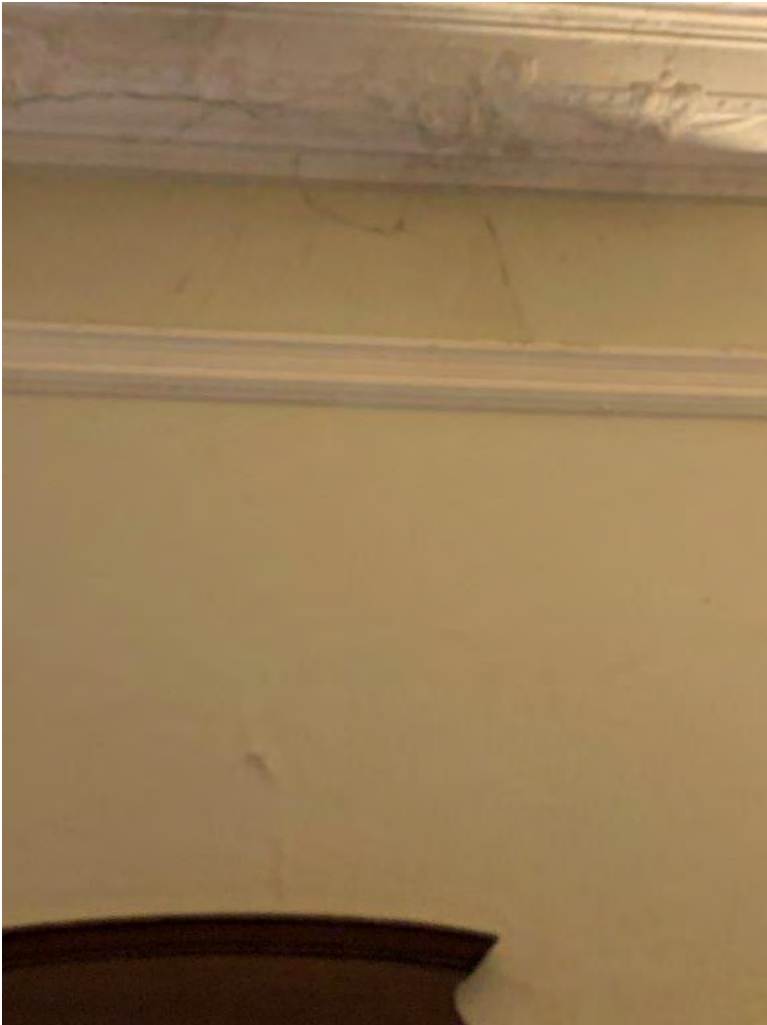
**Photo 6 - Cracks in Brick Wall**

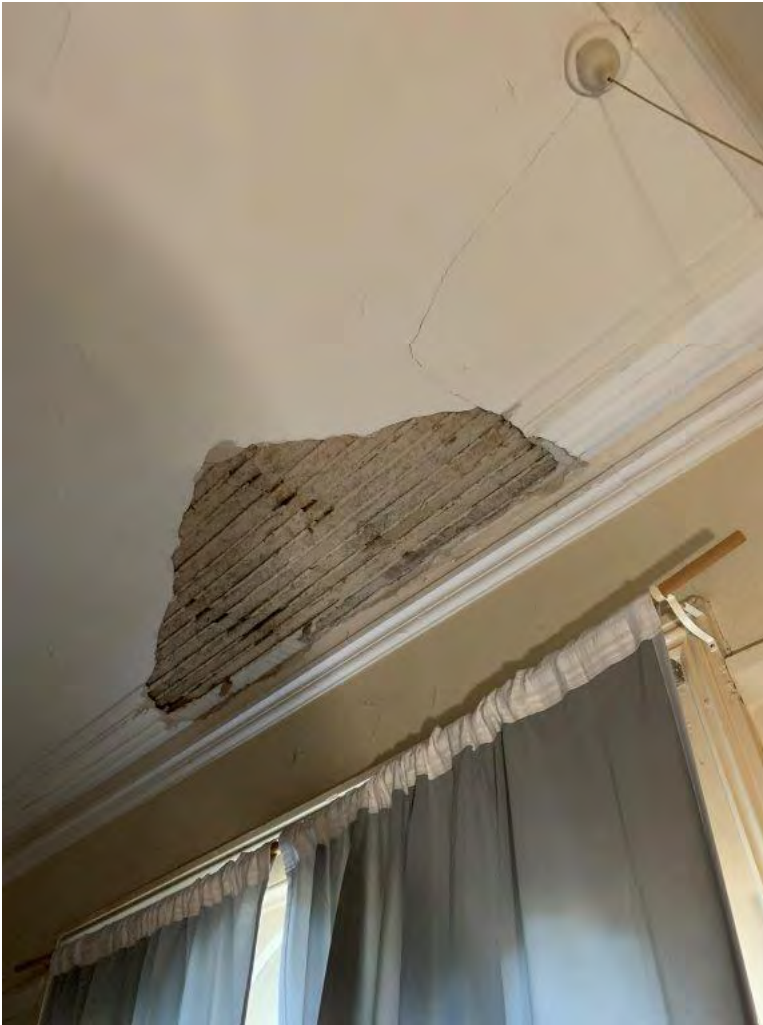
**Photo 7 - Cracks in Ceiling and Brick Wall**

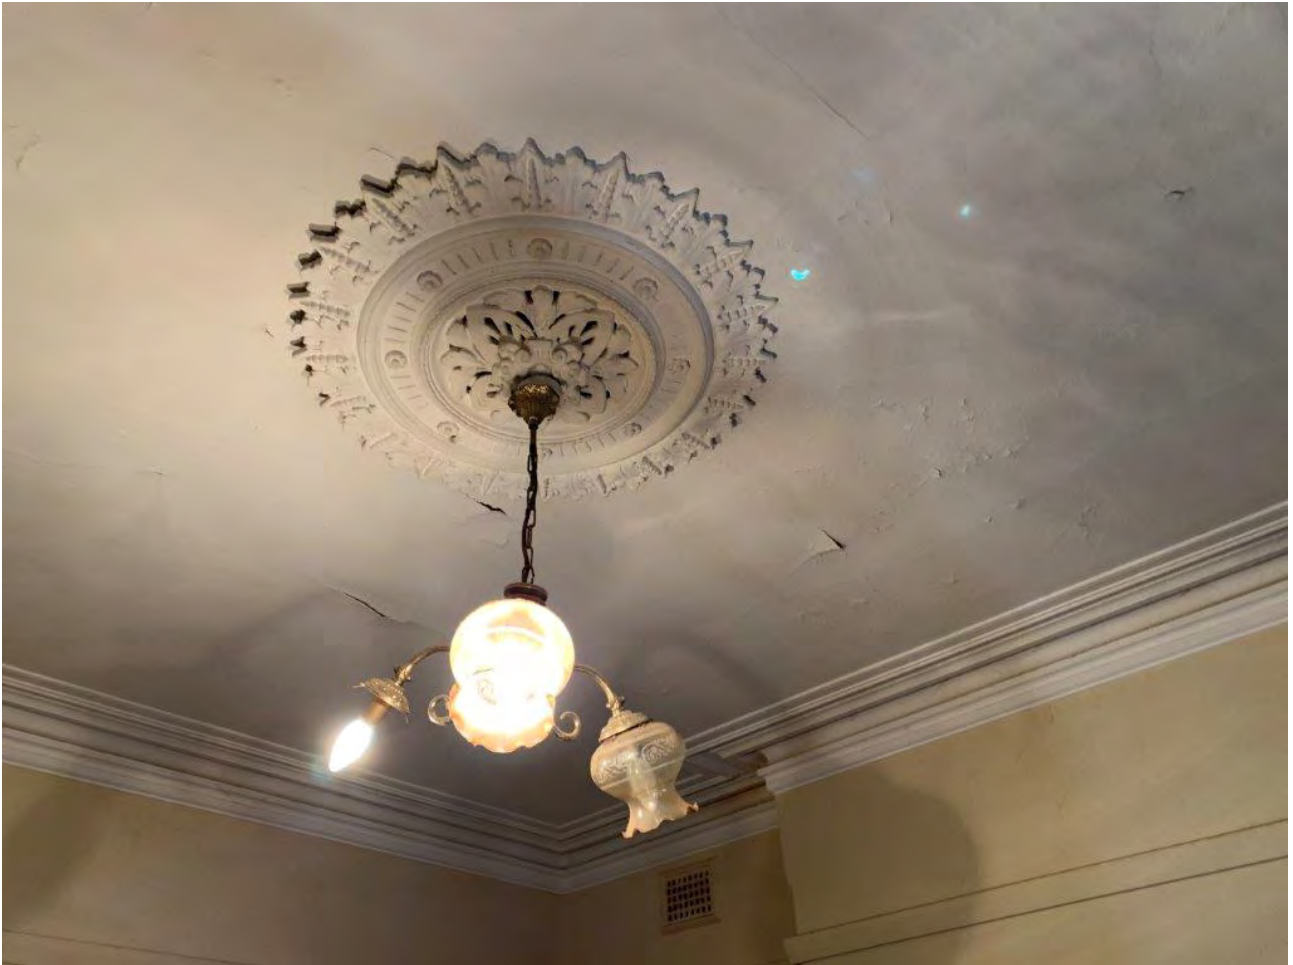
**Photo 8 - Condition of Ceiling**

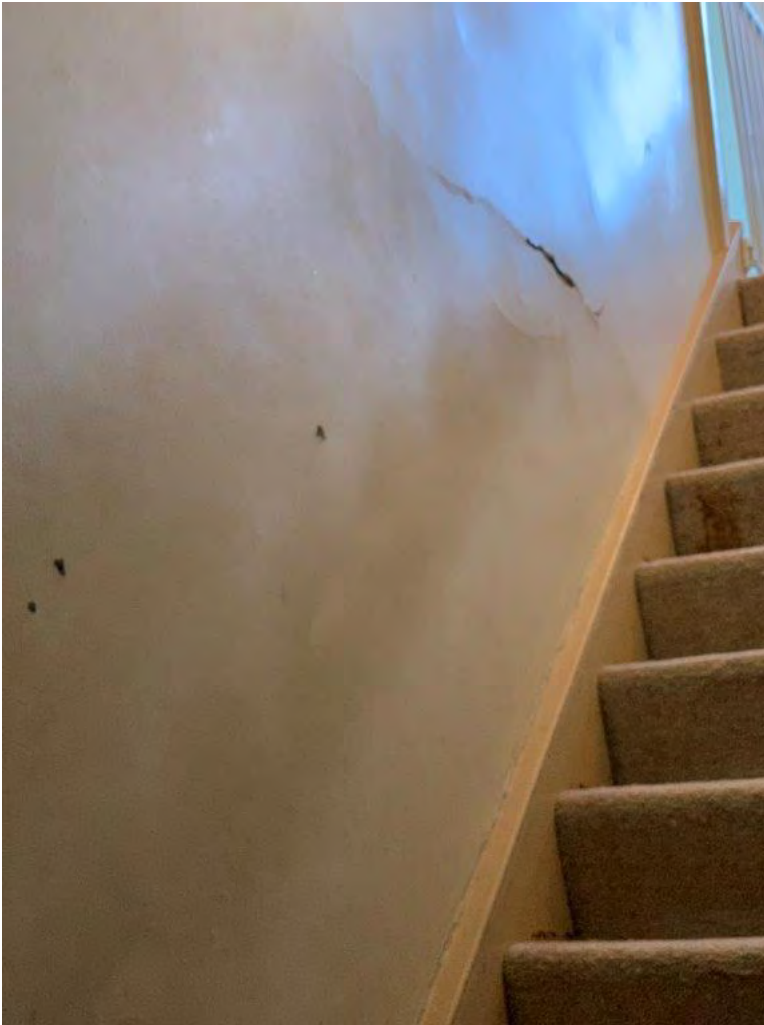
**Photo 9 - Cracks in Brick Wall**

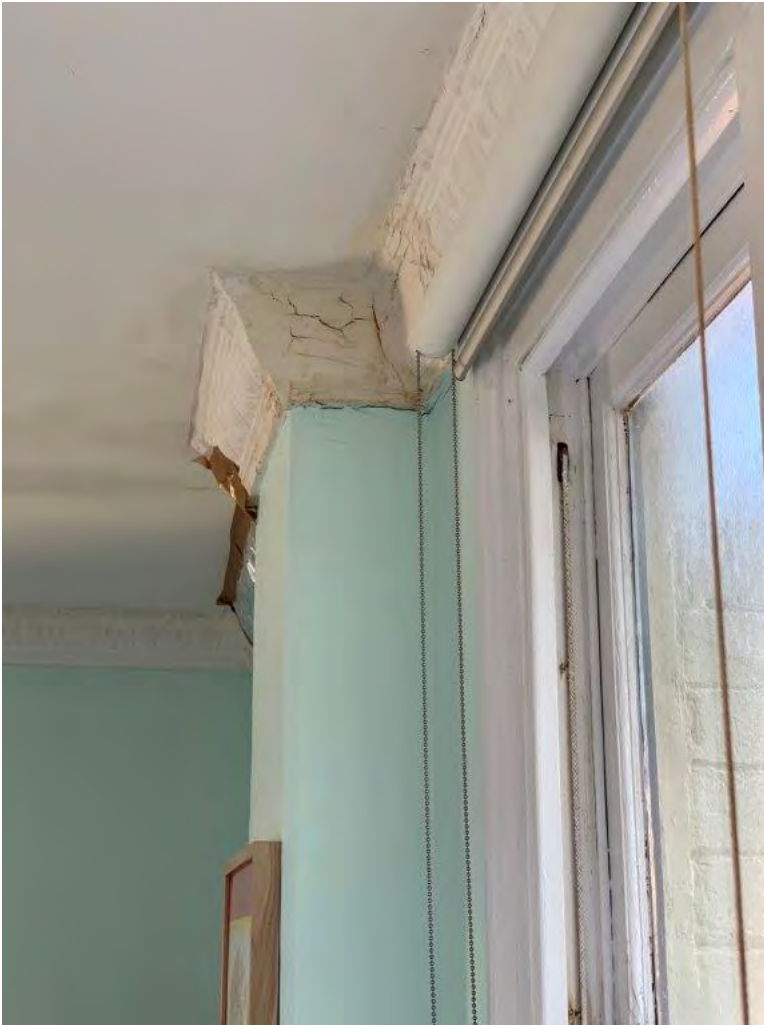
**Photo 10 - Cracks in Brick Wall**

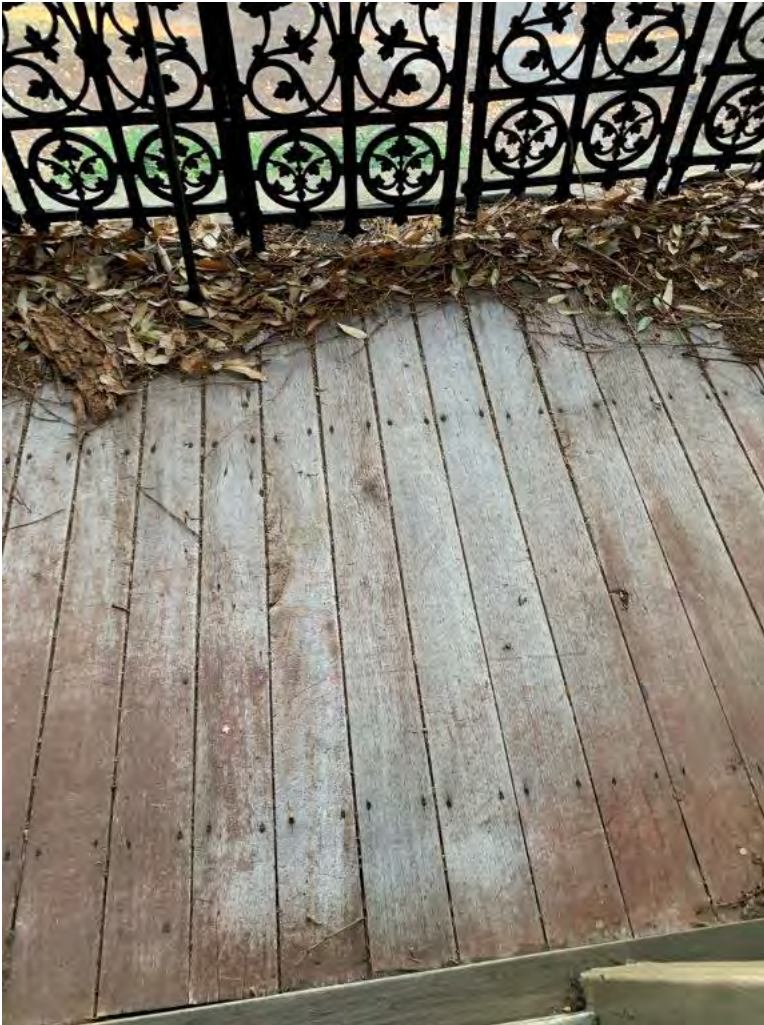
**Photo 11 - Sagging Balcony**

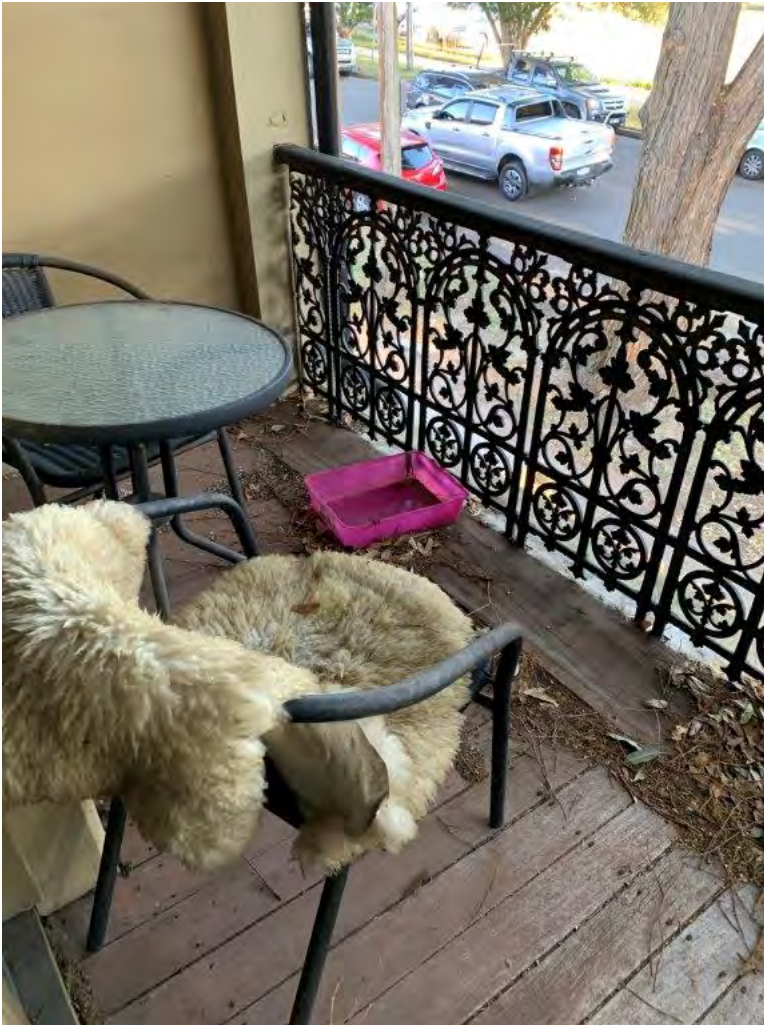
**Photo 12 - Sagging Balcony**

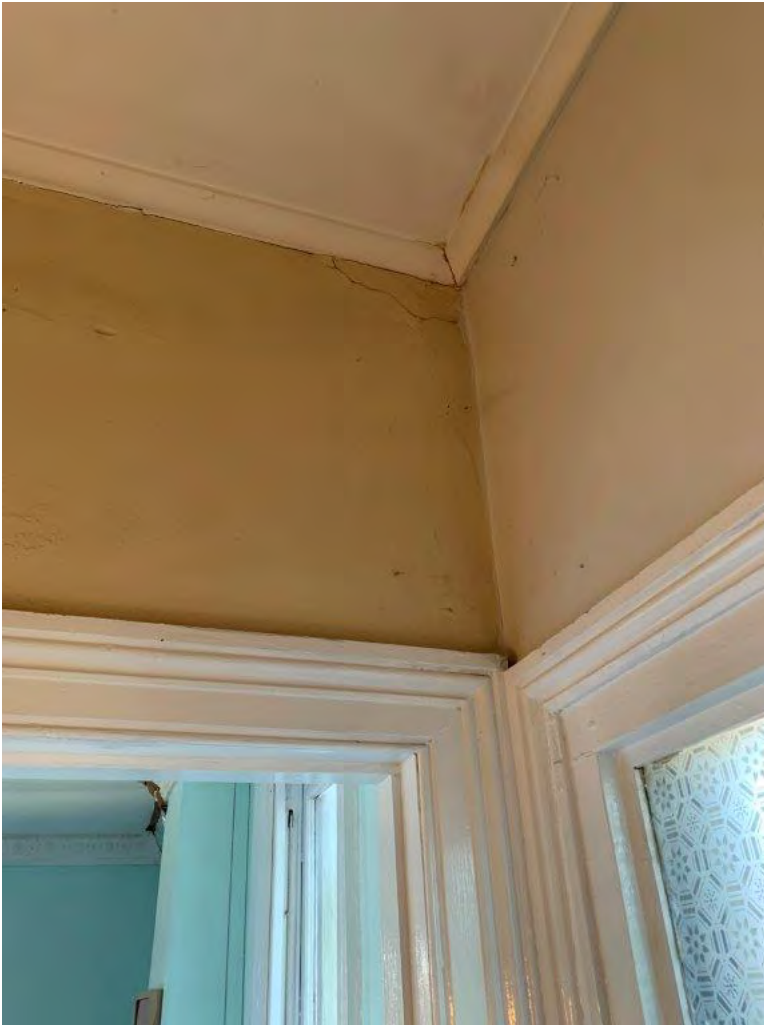
**Photo 13 - Cracks in Brick Wall**

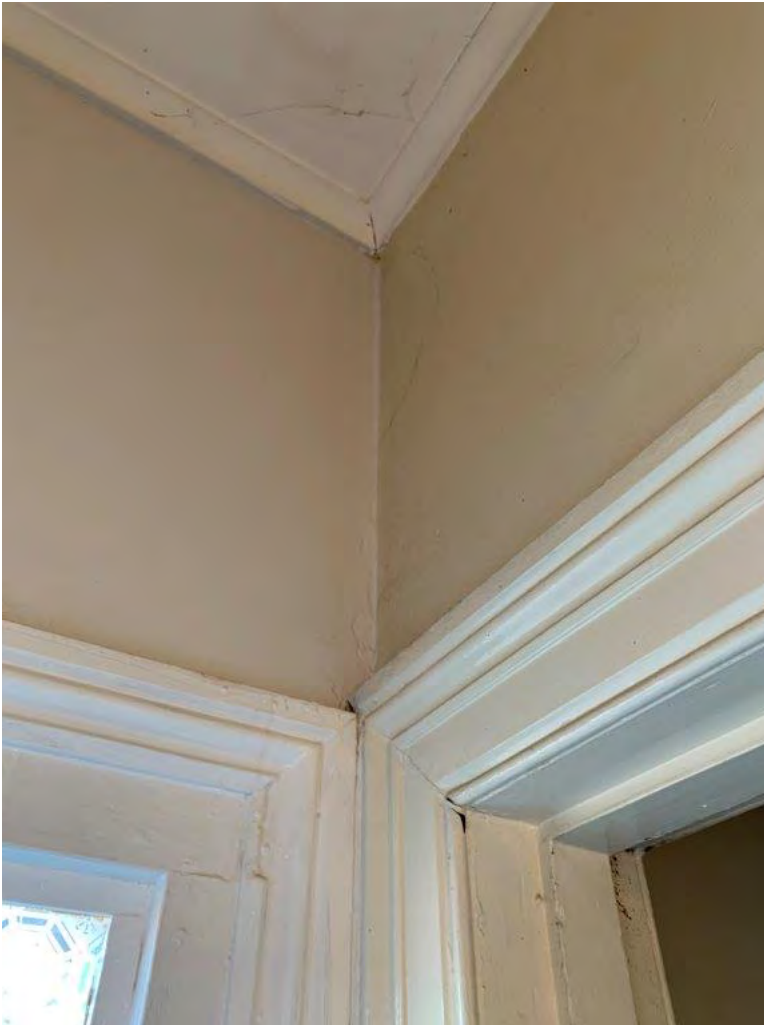
**Photo 14 - Cracks in Brick Wall**

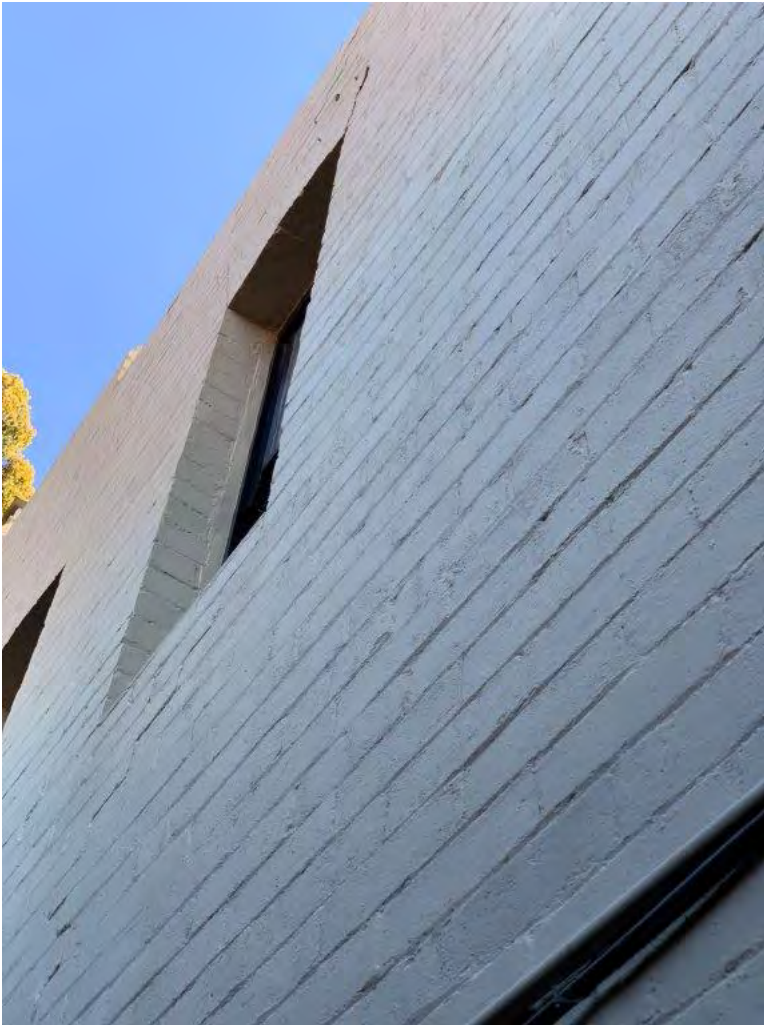
**Photo 15 - Cracks in Brick Wall**

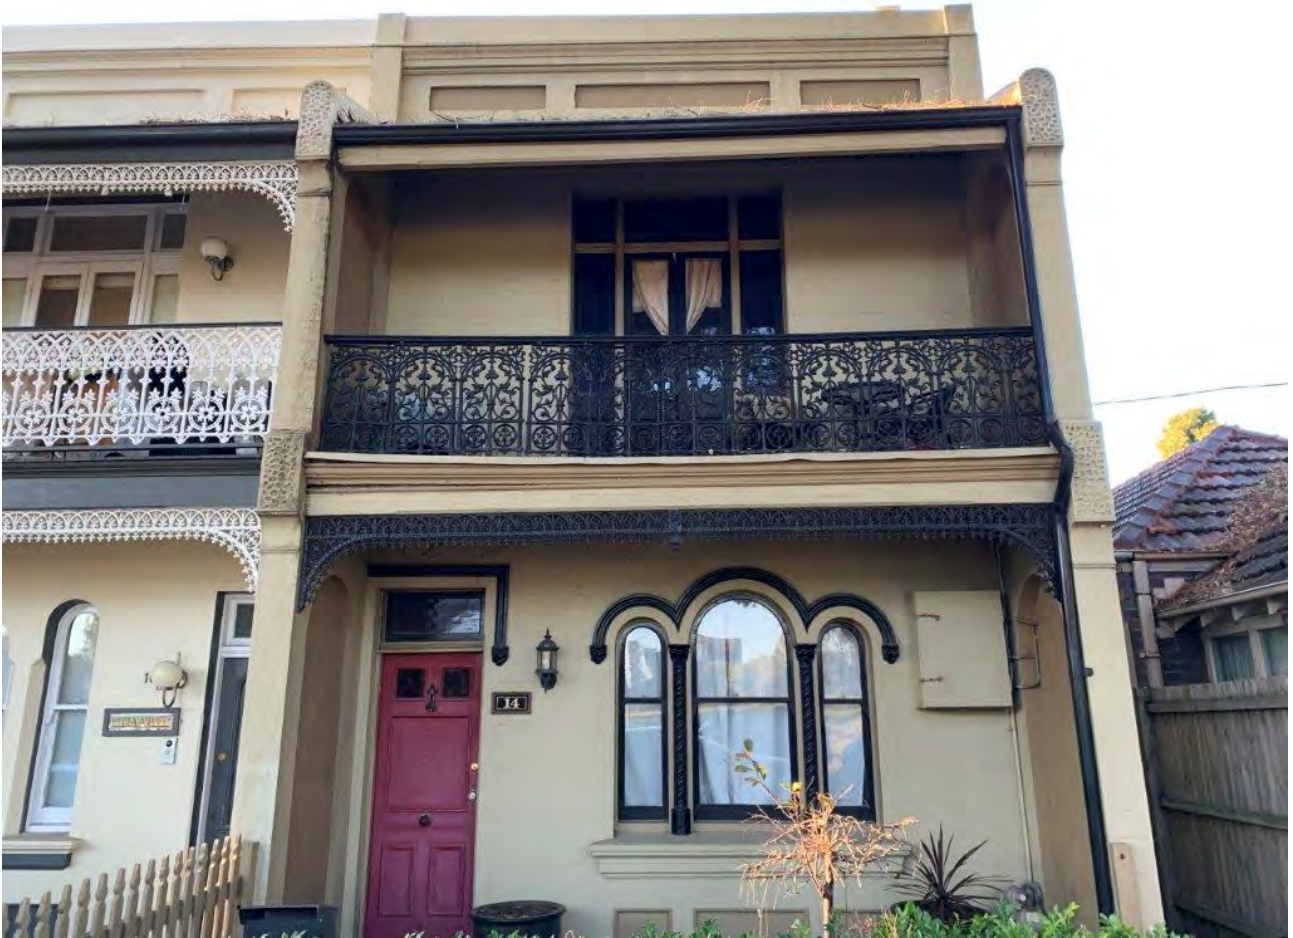
Photo 16 - Sagging Balcony

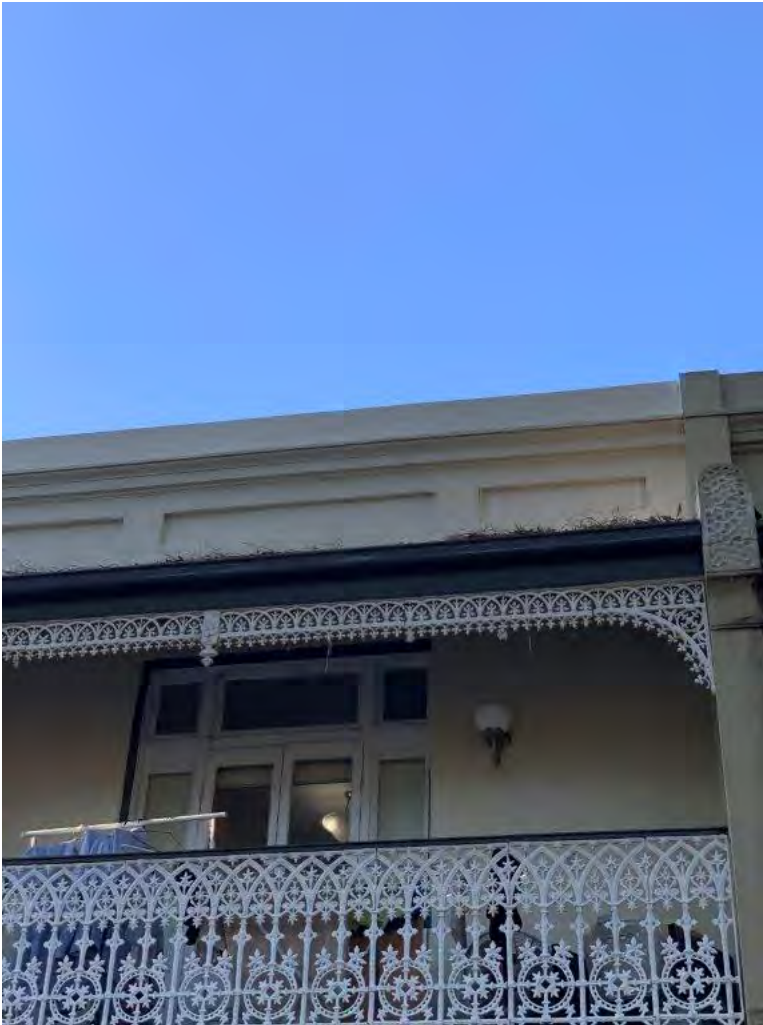
**Photo 17 - Cracks in Brick Parapet at Terrace Number 16**
