**REPORT  
on  
PRELIMINARY GEOTECHNICAL ASSESSMENT**

**OATLEY BOWLING CLUB  
RIVER STREET, OATLEY**

**Prepared for  
HURSTVILLE CITY COUNCIL**

**Project 44456  
December 2006**

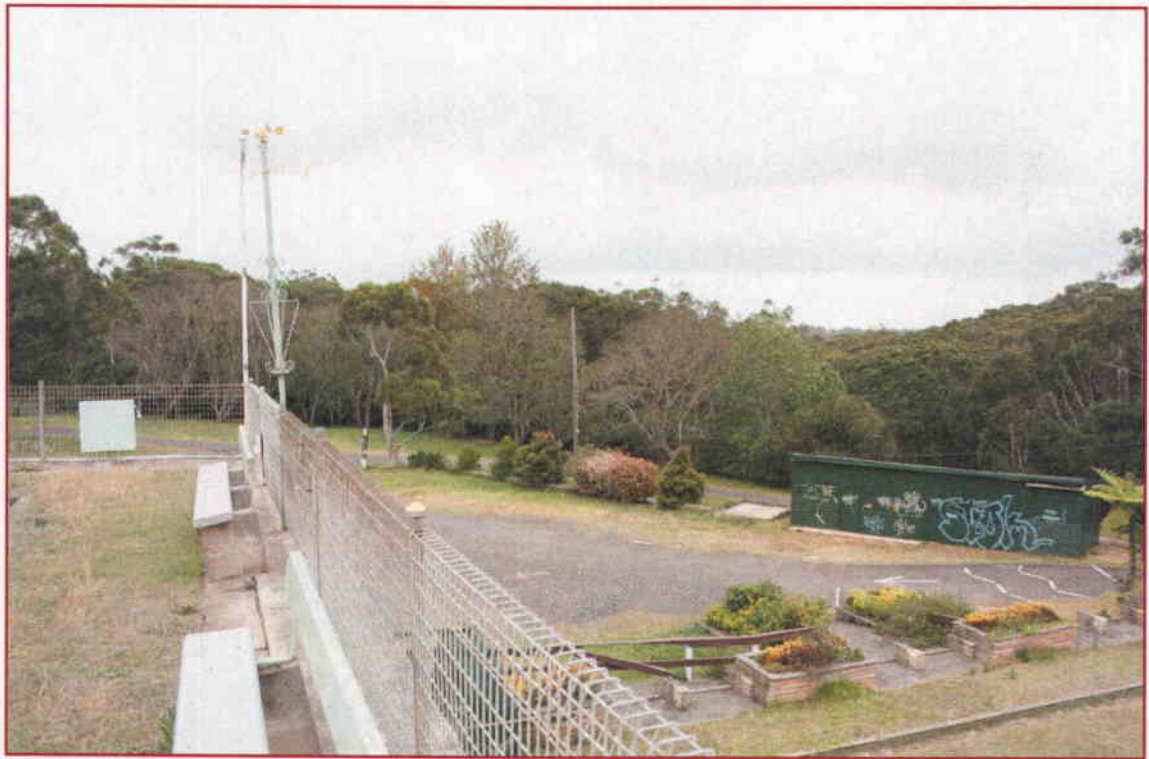
The bowling greens have been built on filling and there is evidence of the filling settling, especially in the area between the actual greens and the retaining walls where the seats are located. Seats in the area have been adjusted by up to the order of 100 mm. See Photos 6 and 7.

**PHOTO 7: Leaning seat indicating settlement**

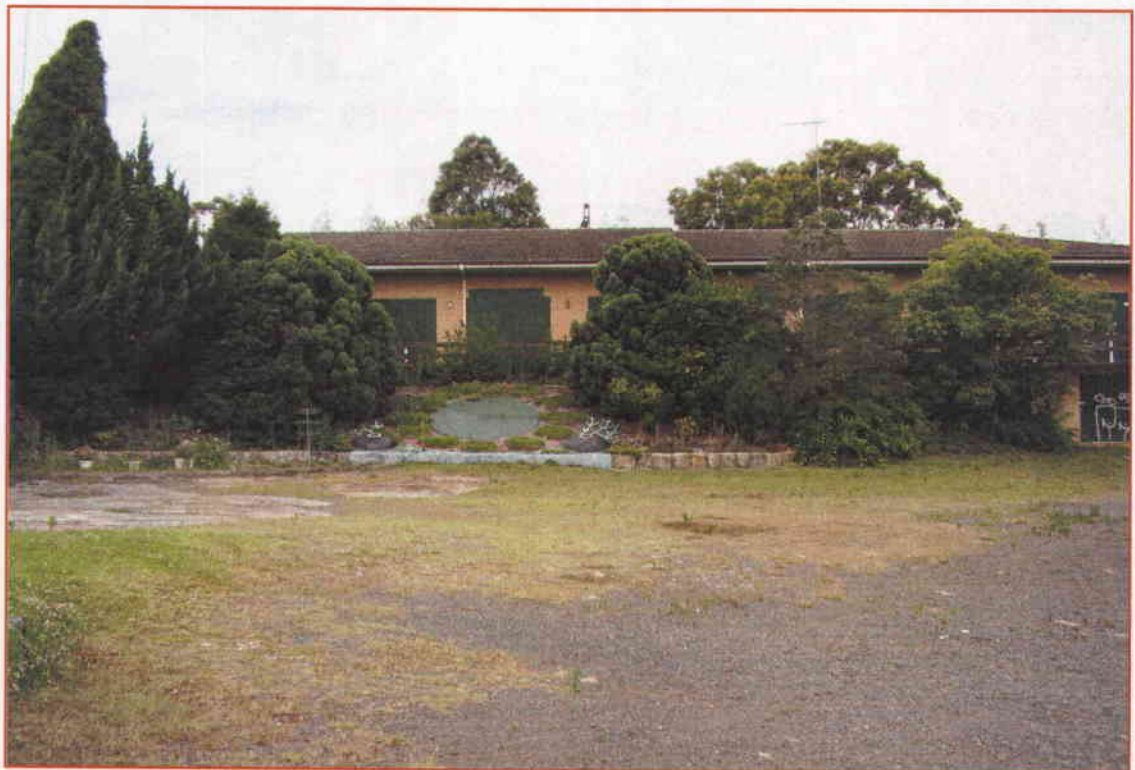
The club house is in relatively good condition as it is probably founded on rock. See Photo 8.

**PHOTO 8: The Club House**

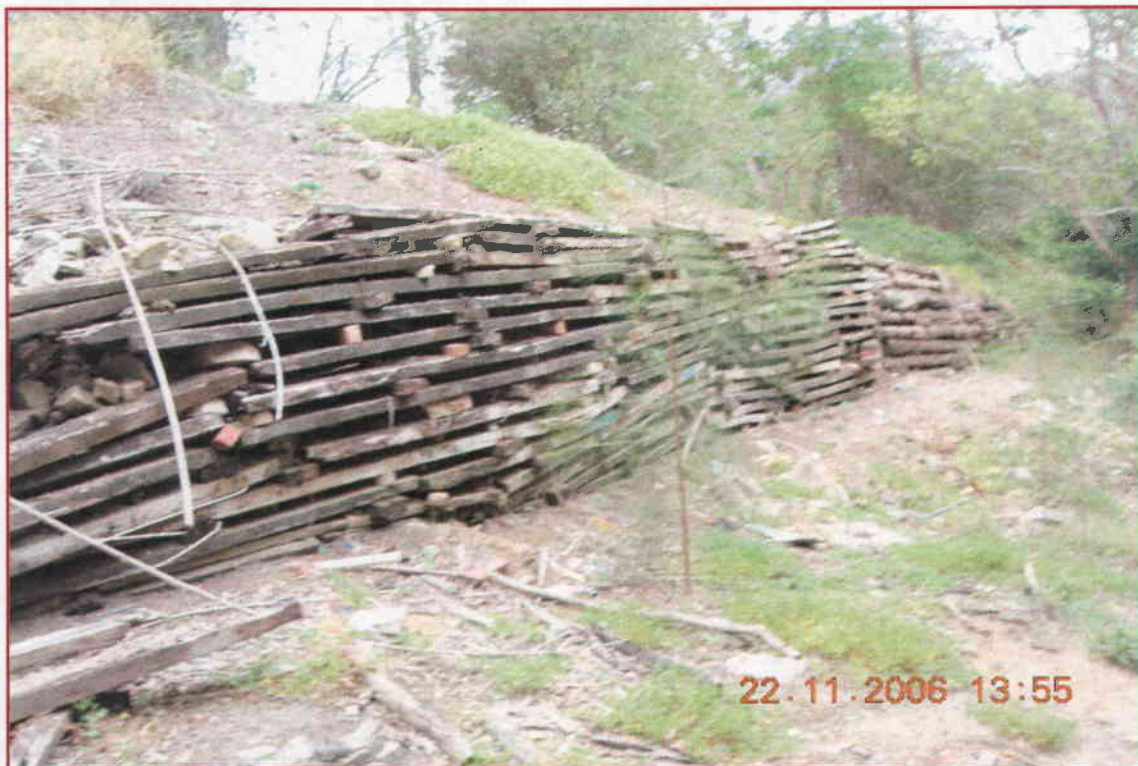
In the southern western corner of the site, the timber crib walls supporting the embankments are in poor condition with many incidences of collapses, washing out of fines and rotting timber. See Photos 9 and 10. Also observed on the embankments was unsuitable material including pipes, large pieces of rock and concrete, steel pieces, plastic and rubbish.

The embankments in the south-western corners of the site are in a poor condition. It is considered that the embankments and any retaining walls should be totally rebuilt as they cannot be relied upon to provide support for a development at the top of the embankments.

PHOTO 9: Timber crib wall

This would involve removal of any remaining retaining walls and the material for some distance behind the faces and could be undertaken in conjunction with the reworking of the uncontrolled filling on the site. There was plenty of unsuitable material exposed in the embankment which should not be reused in the reconstruction of the embankment.

Investigation would be required to assess the ground conditions for new retaining wall foundations. New filling should be placed in horizontal layers and compacted.

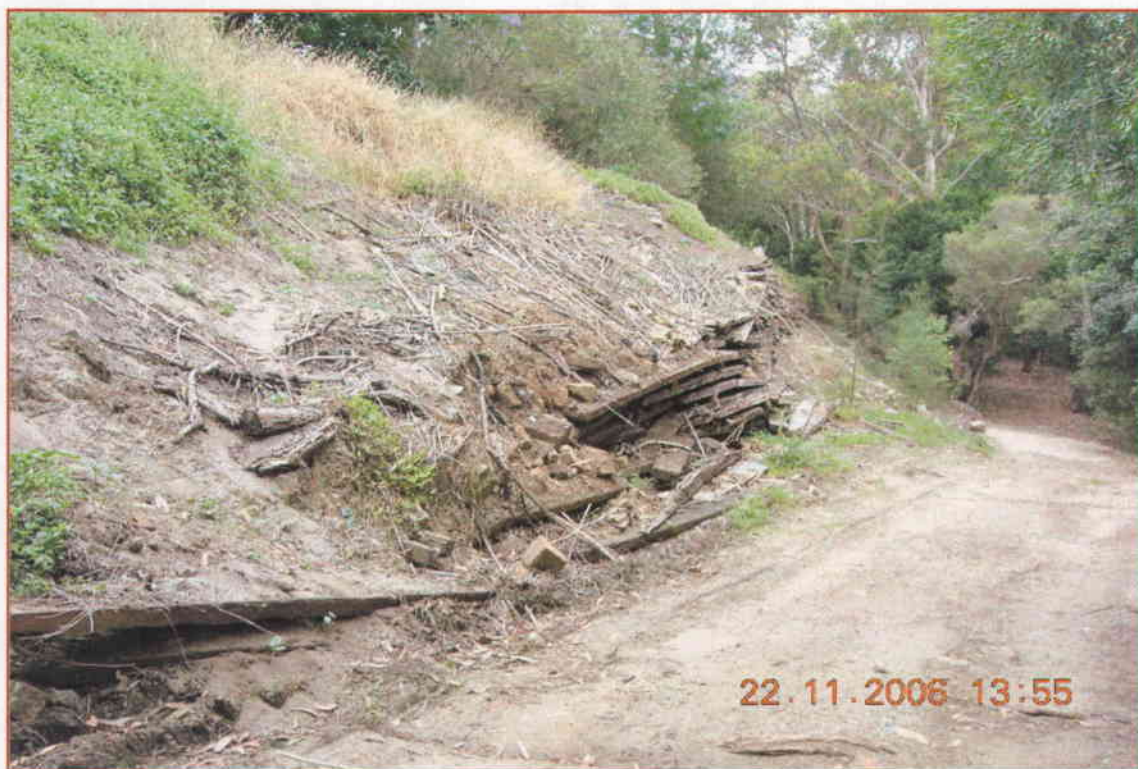
PHOTO 10: Failed crib wall
