**GEOENVIRONMENTAL  
PRELIMINARY SITE INVESTIGATION  
FOR A PROPOSED ADDITIONAL USE  
(CHILD CARE FACILITY)  
AT**

**977 FOREST ROAD, LUGARNO**

Job number: 2354

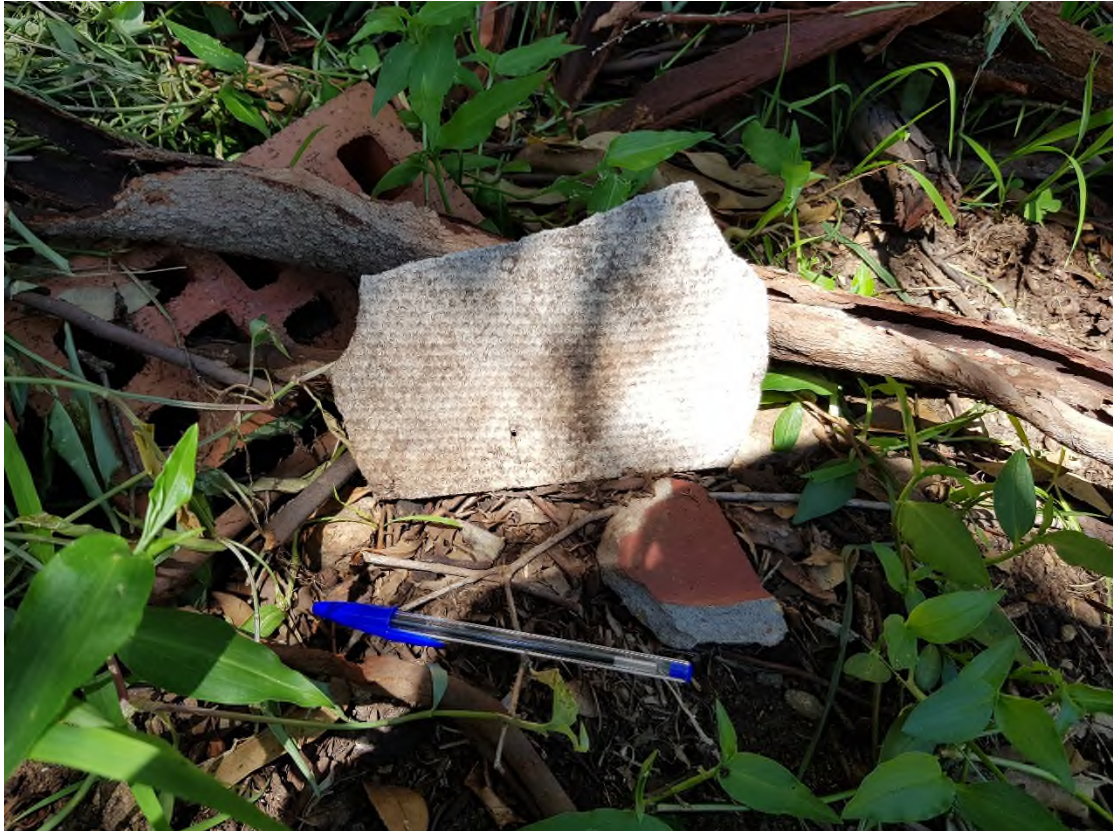
The inspection detected some areas of potential environmental concern. These were areas where there was some rubbish and other building materials along with a piece of potential ACM Material.

**Photo 1: Showing potential ACM fragment**

Based on the results of this Preliminary Site Investigation (PSI) a Scoped Detailed Site Investigation (DSI) is considered necessary to address the potential for asbestos on some areas of the site.

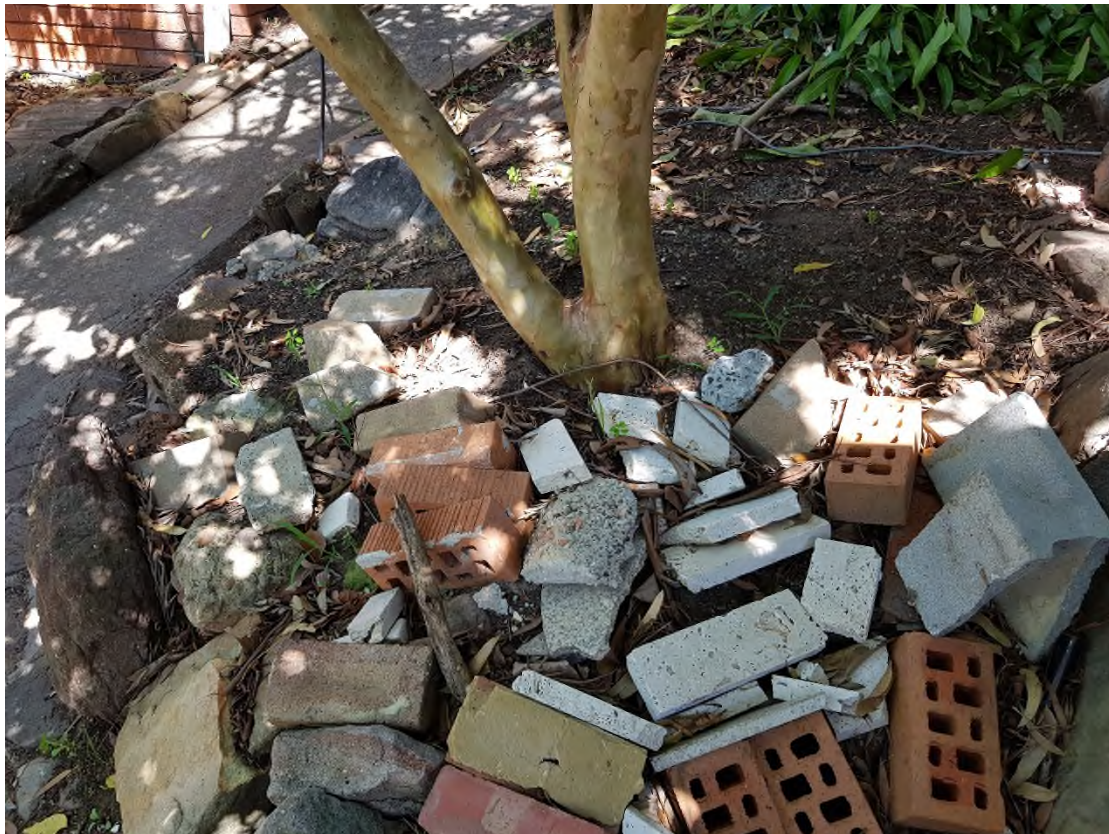
The subject site is composed largely of sealed areas with some exposed soil areas being present. Discussions with the client indicated that asbestos had been removed from the site previously. There was however a piece of potential ACM fragment detected on the property along with various areas where building materials had been dumped.

**Photo 2: Showing various building materials**
