# Arborist development assessment report

977 Forest Road  
Lugarno NSW 2210

Lot 2 DP 405732  
31<sup>st</sup> March 2020

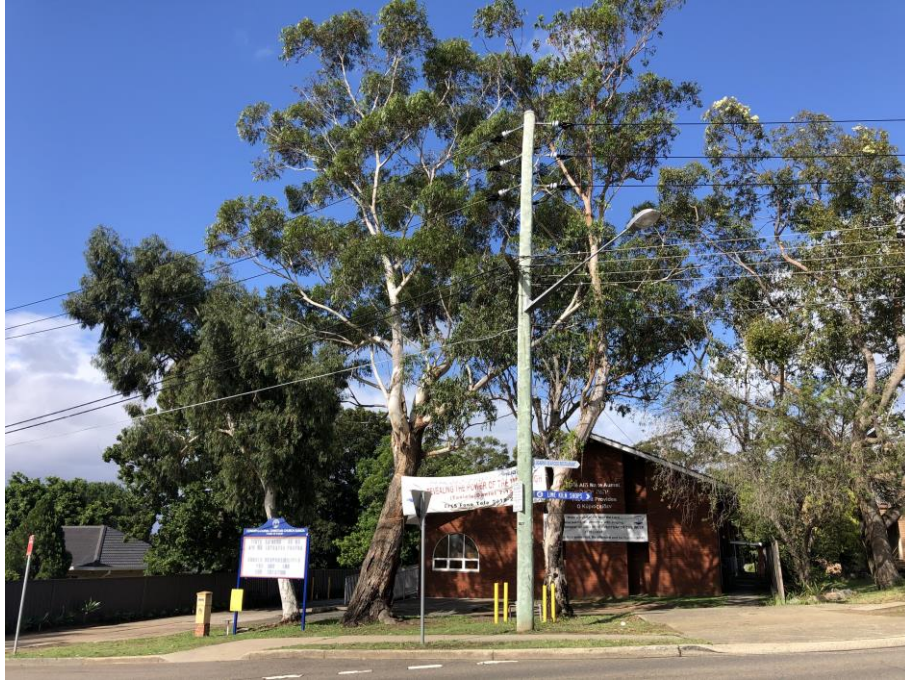
**Plate 1:** From left Trees 1-3. P. Vezgoff.

- 3.5** The site trees consist of all native tree examples in varying conditions. Trees 1-3 are growing on the site frontage and provide good visual amenity to the site (Plate 1). Tree 1 is a mature Grey gum (*Eucalyptus punctata*) growing at 5.4 metres from the southern boundary fence. Tree 2 is a mature Blackbutt (*Eucalyptus pilularis*) and is the largest tree on site. Both Trees 1 and 2 are in excellent health and condition and are good specimens to retain on site. Tree 3, a semi mature, Willow gum (*Eucalyptus scoparia*) is suppressed due to the proximity of Tree 2. Tree 3 has suffered extensive damage to the roots that are located near the surface (Plate 2). The tree is unlikely to recover from this damage and will most likely go into a slow decline in the oncoming years. An existing driveway is located to the north of Tree 3 and this is proposed to be widened. A new driveway entry is proposed to be located to the south of tree 1. (Plate 1).

- 4.4** **Trees 1-3** will require tree protection fencing as specified in Section 5.2 of this report. This fencing will be located at the indicative locations shown in the Tree Protection Plan (Appendix 1). The specifications for a TPZ are in Section 5.3 of this report.

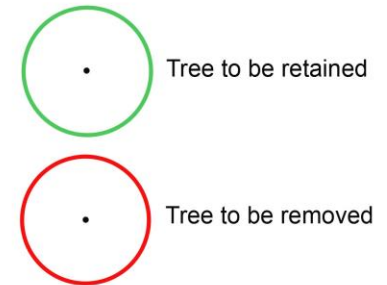
### **Plan 1**

**Mulching.** Area recommended for mulching. Prior to any demolition or construction work mulch shall be applied to a depth of 100mm to this area for the duration of the construction period. Once construction is complete the mulch shall be reduced to a depth of no greater than 70mm.

- 5.2 Implementation of Tree Protection Zone:** All tree protection works should be carried out before the start of demolition or building work. It is recommended that chain mesh fencing with a minimum height of 1.8 metres erected as shown in the Tree Protection Plan (Appendix 1).

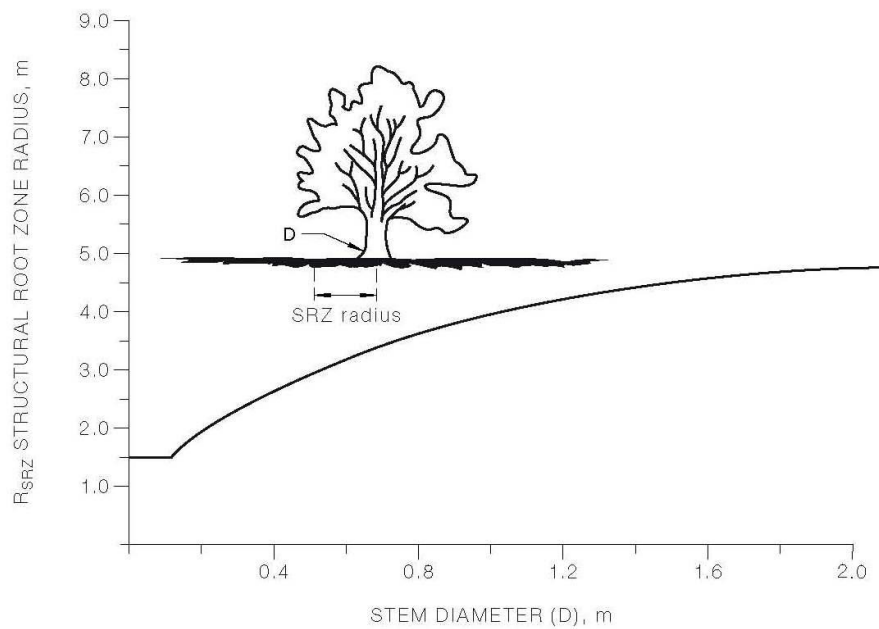
**FIGURE 1 - STRUCTURAL ROOT ZONE**

The curve can be expressed by the following formula:  
 $R_{SRZ} = (D \times 50)^{0.42} \times 0.64$

- 1  $R_{SRZ}$  is the structural root zone radius.
- 2  $D$  is the stem diameter measured immediately above root buttress.
- 3 The SRZ for trees less than 0.15 metres diameter is 1.5 metres.
- 4 The SRZ formula and graph do not apply to palms, other monocots, cycads and tree ferns.
- 5 This does not apply to trees with an asymmetrical root plate.
