Hurstville Street Tree Management Study

Inventory, issues and future management

Prepared for
Hurstville City Council

22 April 2015

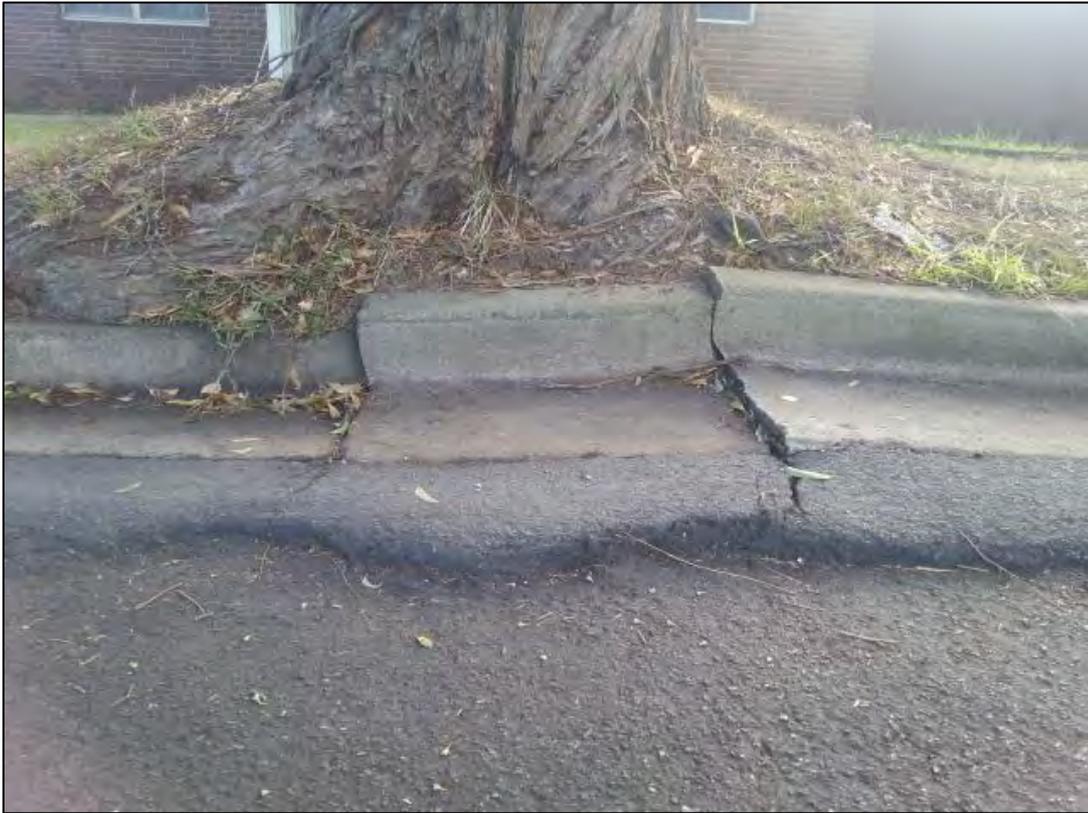
Figure 3: Street trees can cause damage to surrounding pavement and infrastructure

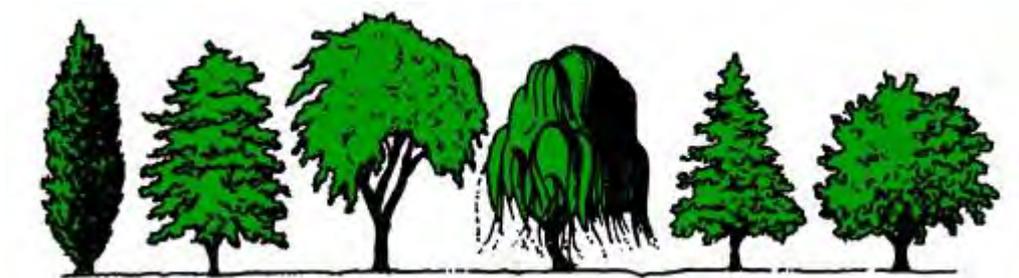
Figure 4: Trees were defined as a species with a growth habit with a single upright trunk and canopy (Image source: <http://www.ext.colostate.edu/mg/gardennotes/121.html>)

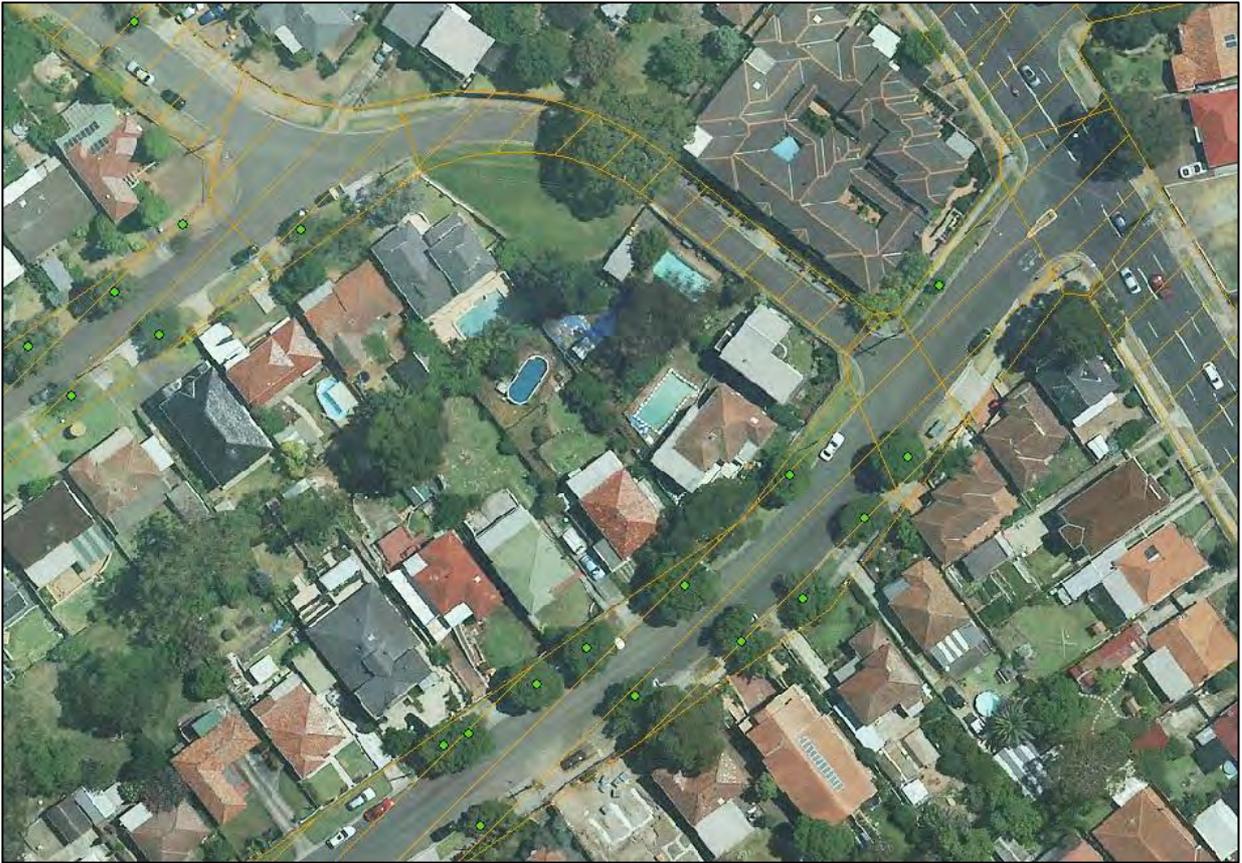
Figure 5: Screenshot of digitised trees within ArcGIS10.2. Only trees with trunks within Hurstville Roads layer where marked. Trees are marked with a green dot.

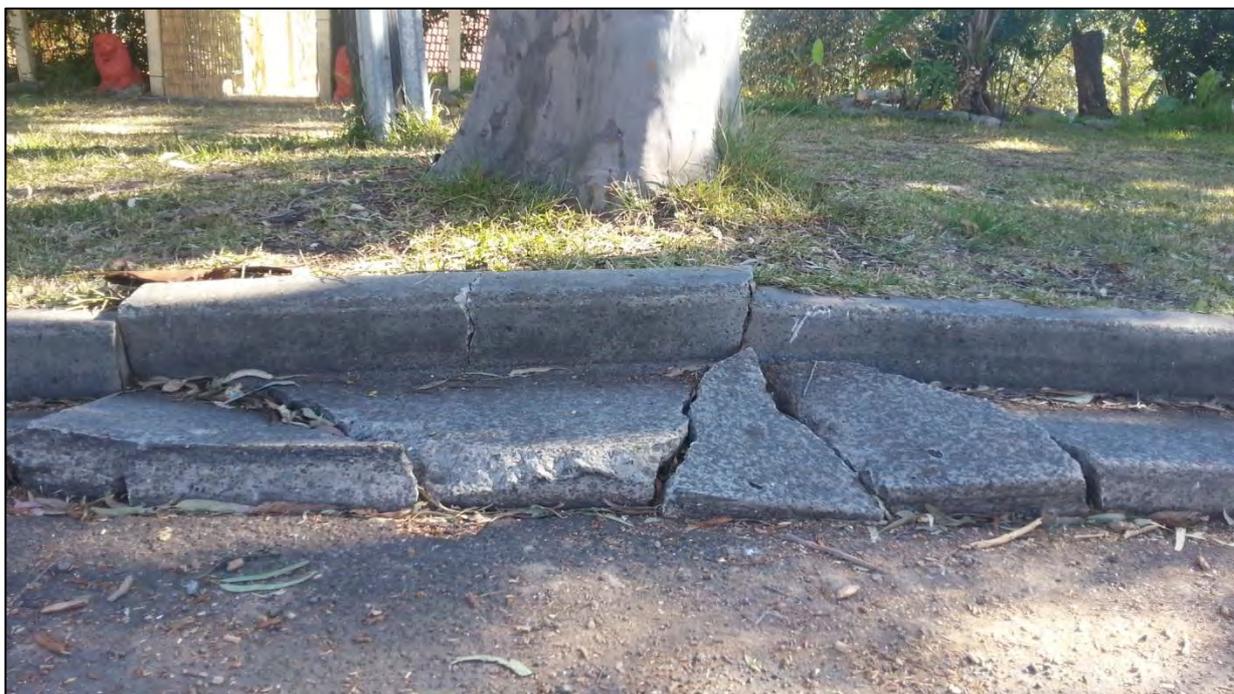
Figure 10: Example of kerb and gutter regarded with 'Severe' damage. This damage category was defined as having "Extensive surface cracking with displacement of damaged portion(s) greater than 20mm".

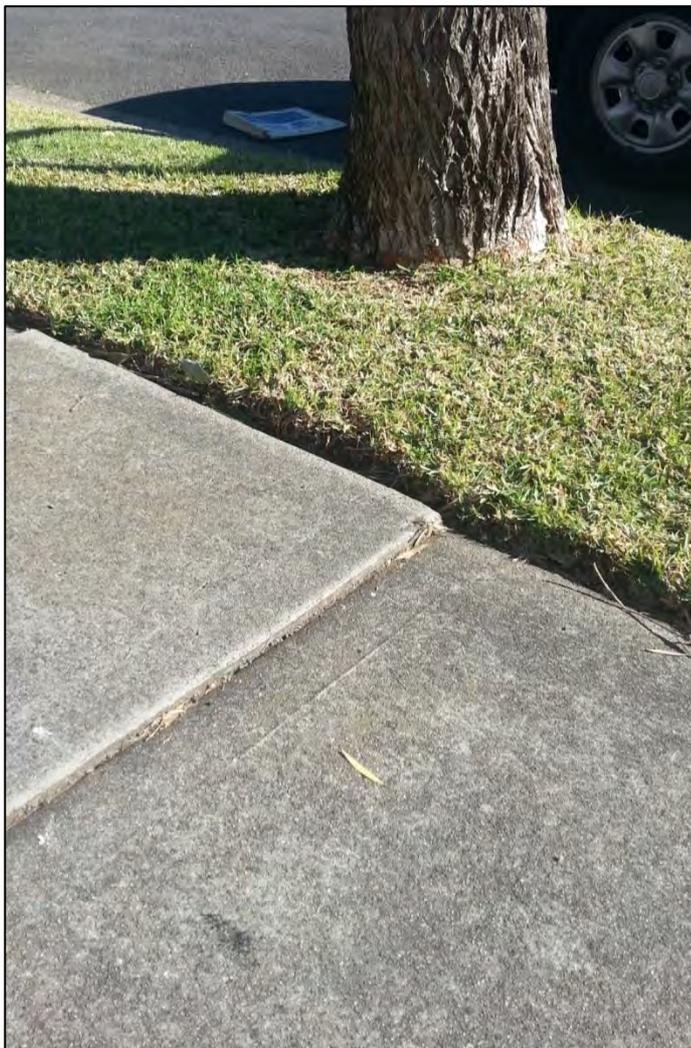
Figure 11: Example of pavement/surrounding material with 'moderate' damage. This damage category was defined as having "Some surface cracking with displacement of damaged portion(s) not exceeding 20mm".

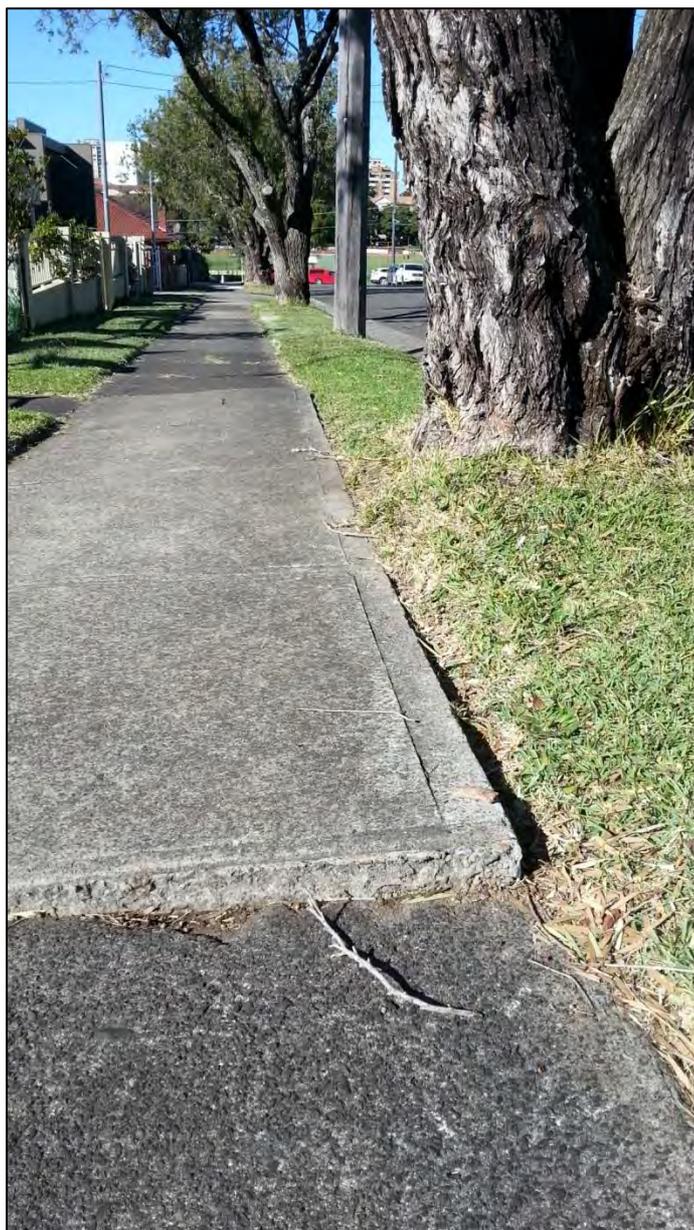
Figure 12: Example of pavement/surrounding material with ‘severe’ damage. This damage category was defined as having “Extensive surface cracking with displacement of damaged portion(s) greater than 20mm”.

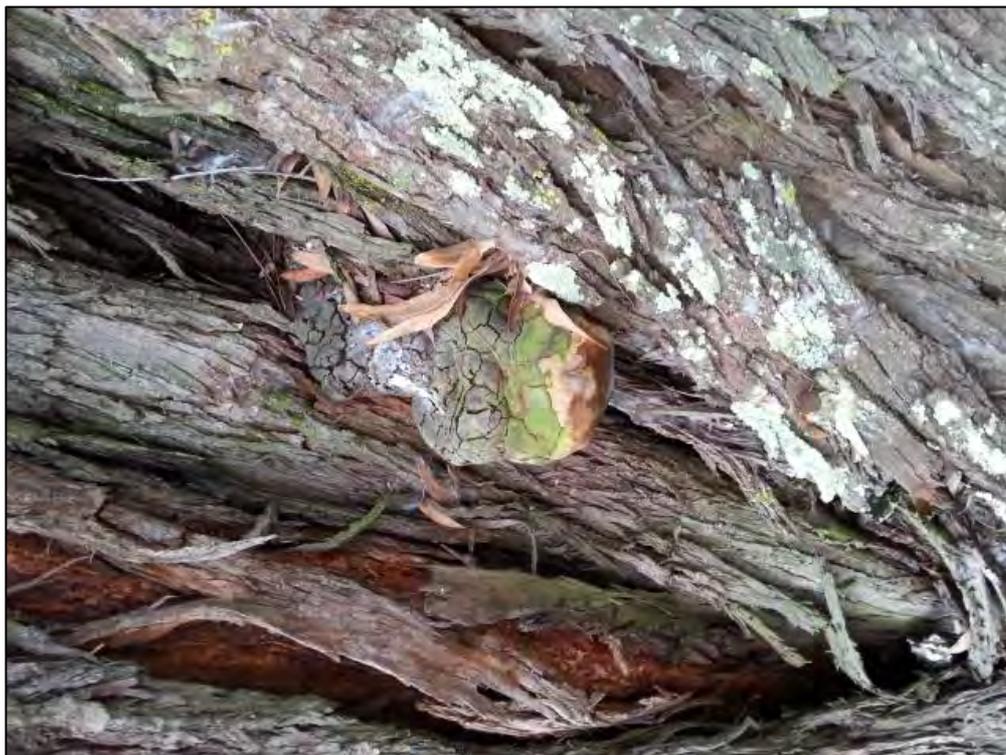
Figure 13: Trees that were assigned as having ‘poor’ health showed signs of pest or diseases such as this bracket fungus.

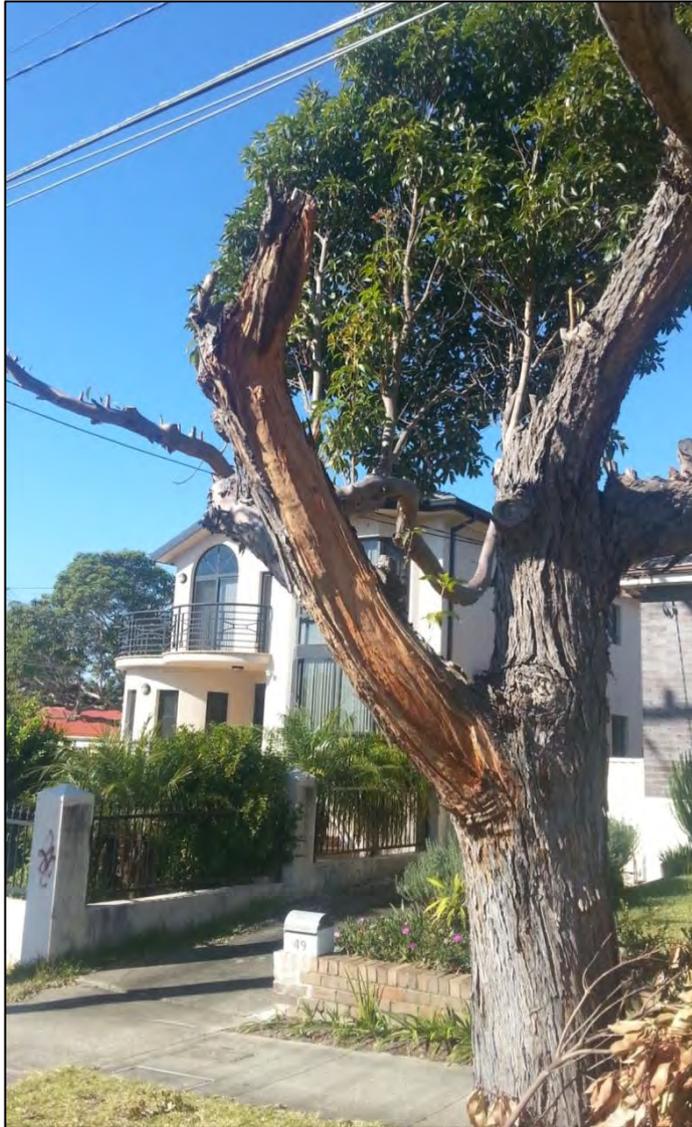
Figure 14: 'Pruning' was recommended where it was thought that the tree health could be improved. These trees often had dead, dying or damaged branches as illustrated here.
